Manhole Inspection Summary

Manhole # S15WW_029MH

Location Address: **3300 DRUID PARK DR**

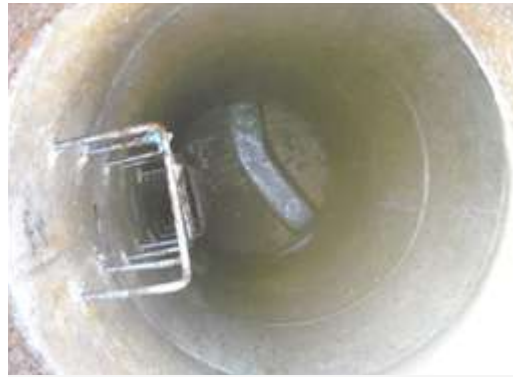
Top View

WE HAD TO DIG GRASS TO EXPOSE
MH

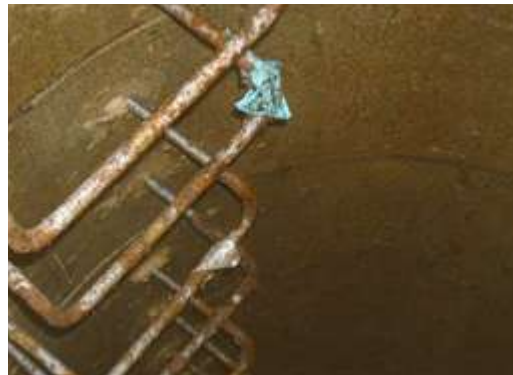
Defect 1

Surcharge ☒ **Evidence Of Surcharge** Depth: **8** (ft.) ☐ Active Surcharge Present

SURCHARGE EVIDENCE

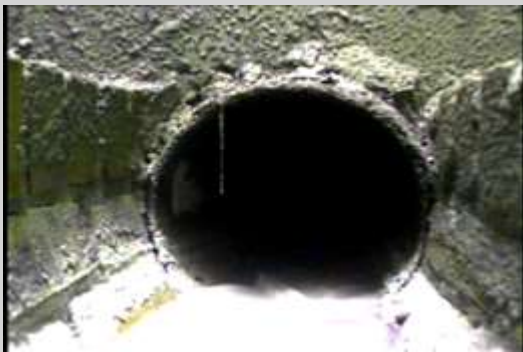
12 O'Clock Outflow

10 in. Circular Gravity Sewer
Pipe Out @ 12 O'Clock

Pipe Height: **9.6** (in.) Rod and Bar (Angled)
Pipe Material: **Clay** ☐ Pipe Lined
Invert Depth: **12.78** (ft.) Flow Characteristics: **Slow**
Deposits: ☒ None ☐ Mud ☐ Sludge ☐ Debris ☐ Grease
Silt Depth: (in.) Deposits Extent:
Infiltration: **None** Pipe Seal Cond: **Sound**

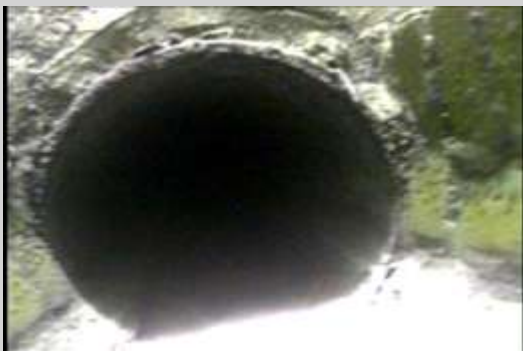
4 O'Clock Inflow

10 in. Circular Gravity Sewer
Pipe In @ 4 O'Clock

Pipe Height: **9.6** (in.) Rod and Bar (Angled)
Pipe Material: **Clay** ☐ Pipe Lined
Invert Depth: **12.75** (ft.) Flow Characteristics: **Fast**
Deposits: ☒ None ☐ Mud ☐ Sludge ☐ Debris ☐ Grease
Silt Depth: (in.) Deposits Extent:
Infiltration: **None** Pipe Seal Cond: **Sound**
